Health Check Report [REDACTED]
December 2015

Continuous Monitoring of the LTHW Heating system.

Hevasure Ltd

21/12/2015

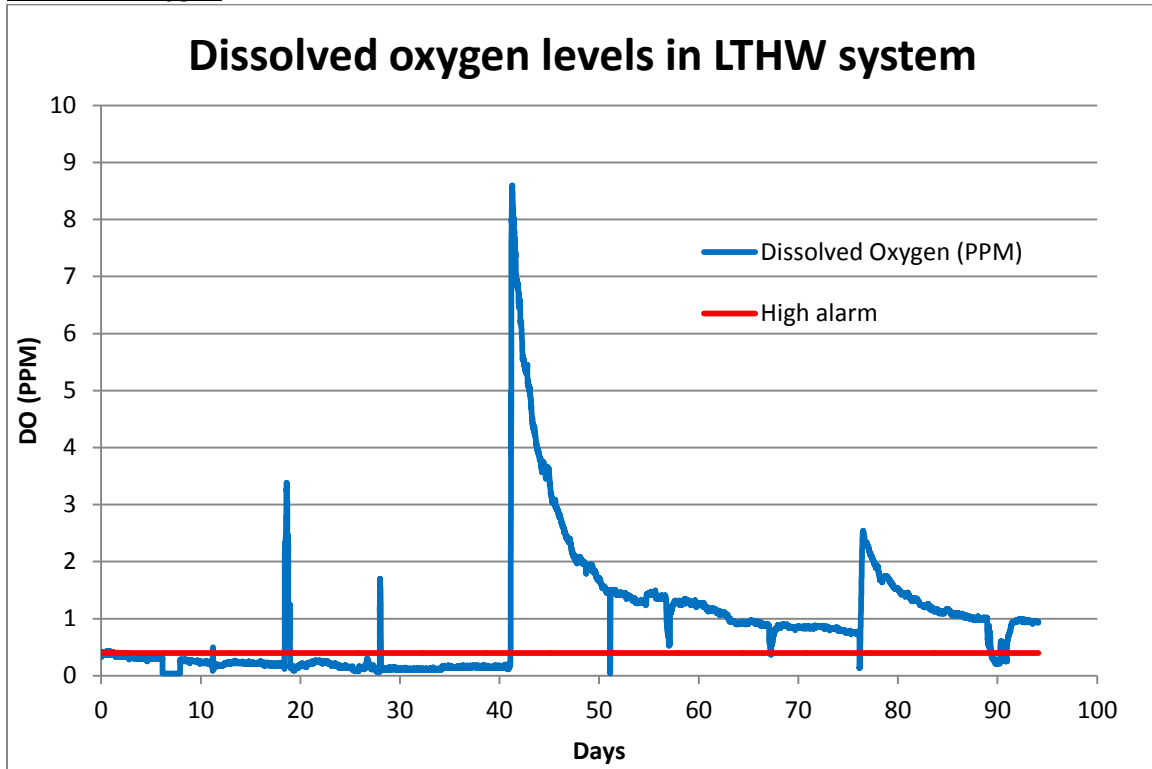
Dissolved Oxygen

Issues of concern: Dissolved oxygen levels have been higher than ideal for much of the monitoring period and increased dramatically on days 11, 18 and 28 when large quantities of fresh water were detected entering via the make-up line into the pressurisation unit. See water make-up chart. However on day 41 (21/10/15) the system water reached to saturation levels (of dissolved oxygen) during which no significant amount of make-up water entered the system. It is understood that event coincided with partial drainage of the system during repair operation. Since that time, the dissolved oxygen gradually decreased (probably a result of oxidation / reduction reactions) but then increased again on day 76 (25/11/2015). At the last reading 13/12/2015 dissolved oxygen was still well above recommended levels at nearly 1 ppm.

In order to help understand what can be causing dissolved oxygen to be increasing at certain times further consideration has been given to the two main possible causes; namely, introduction of air or the addition of fresh, oxygenated make-up water. For a system of 4000 litres the amount of air needed to increase the dissolved oxygen by 1ppm has been calculated at 14 litres. Conversely (since incoming water only contributes around 10 ppm DO at 20C) the amount of fresh water needed to increase the dissolved oxygen by 1ppm has been calculated at 400 litres. The increase in dissolved oxygen is therefore felt to come from both sources (contribution from make-up water alone cannot explain the increases). It is summarised that high flow rates of water entering the pressurisation unit cause gaseous air to also be drawn-in during the filling of the 4 litre tank.

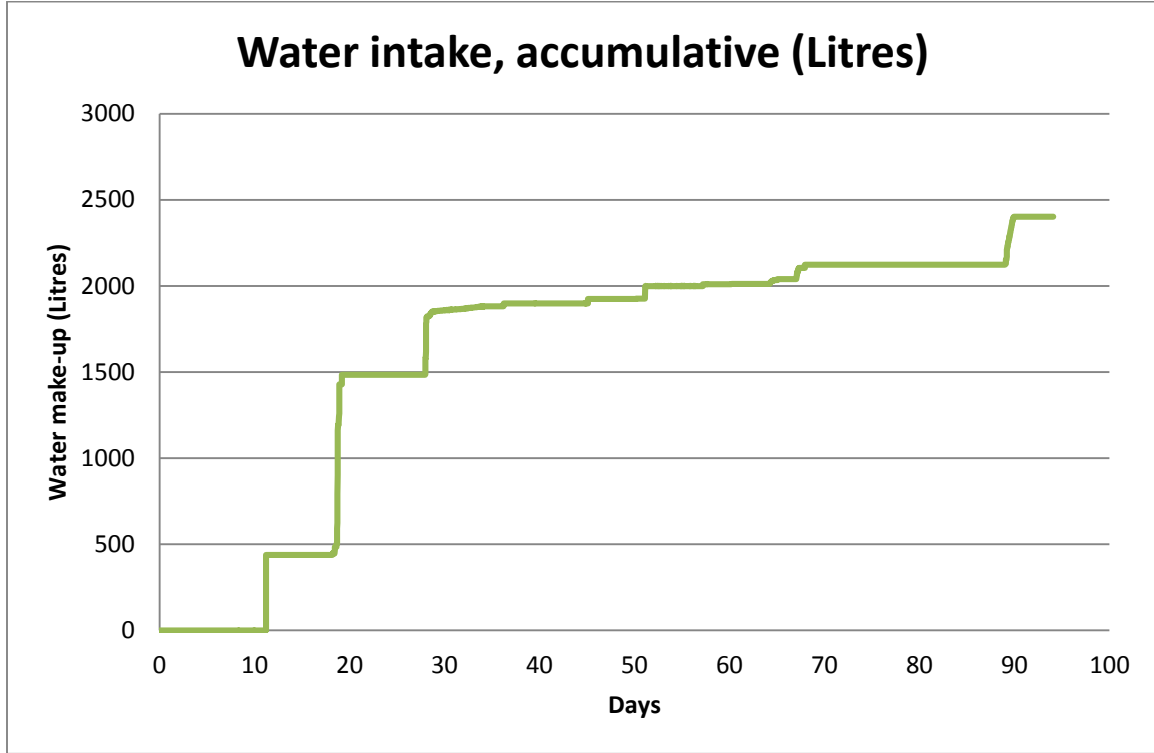
Water make-up

Issues of concern: The chart of water intake (make-up) shows that fresh aerated water is continuing to be drawn into the system. Significant water losses were detected (by pulses from the water meter) on the following days

Day	Date	Approx volume intake	Over time period
11	21/09/2015	435	1 hour
18	29/09/2015	750	3 hours
28	08/10/2015	500	4 hours
89	08/12/2015	275	24 hours

It is noticeable that the events of day 11, 18 and 28 coincided with sudden increases in dissolved oxygen. However, the slow fresh water intake between days 89 and 90 coincided with a drop in dissolved oxygen.

Confirmation of the large intake of fresh water has come from the dial on the water meter (2108 litres between 18/09/15 and 09/12/15)

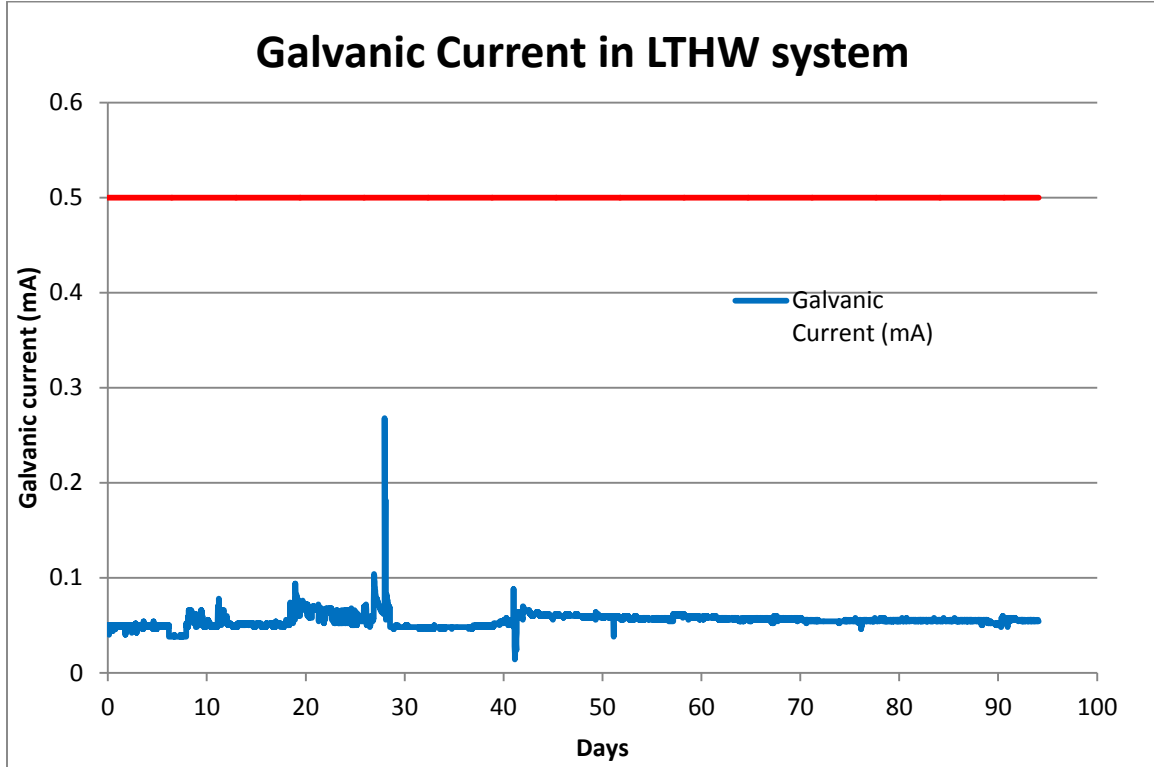
Galvanic Currents

Issues of Concern: None –Galvanic currents between steel and copper have been negligible except for a sudden increase around day 28 (coinciding with an increase in DO). The fact that galvanic currents are low does indicate that the inhibitor is suppressing corrosion of steel on open surfaces (but not necessarily under debris and in crevices)

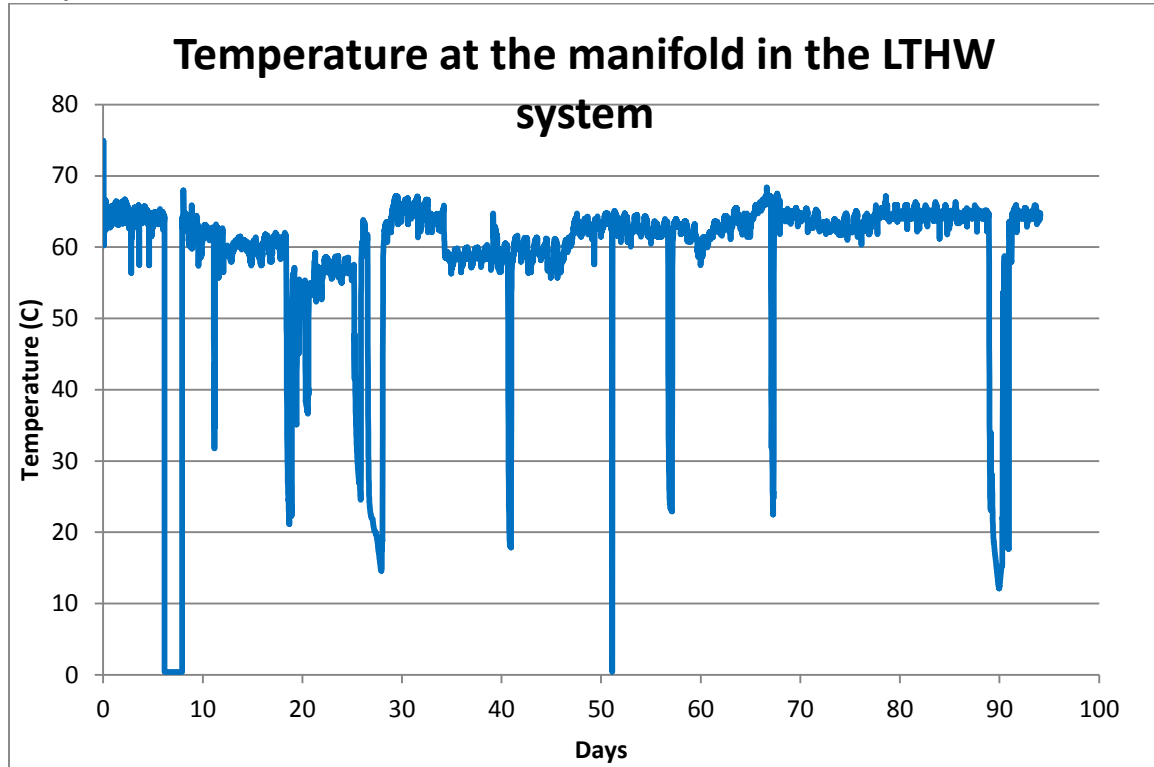
Temperature

Issues of concern: None. The chart shows the temperature measured in the manifold which is slightly lower than that in the main system due to heat loss. Fluctuations have occurred however, probably as a consequence of maintenance activities (draining and refilling?) and changes in demand.

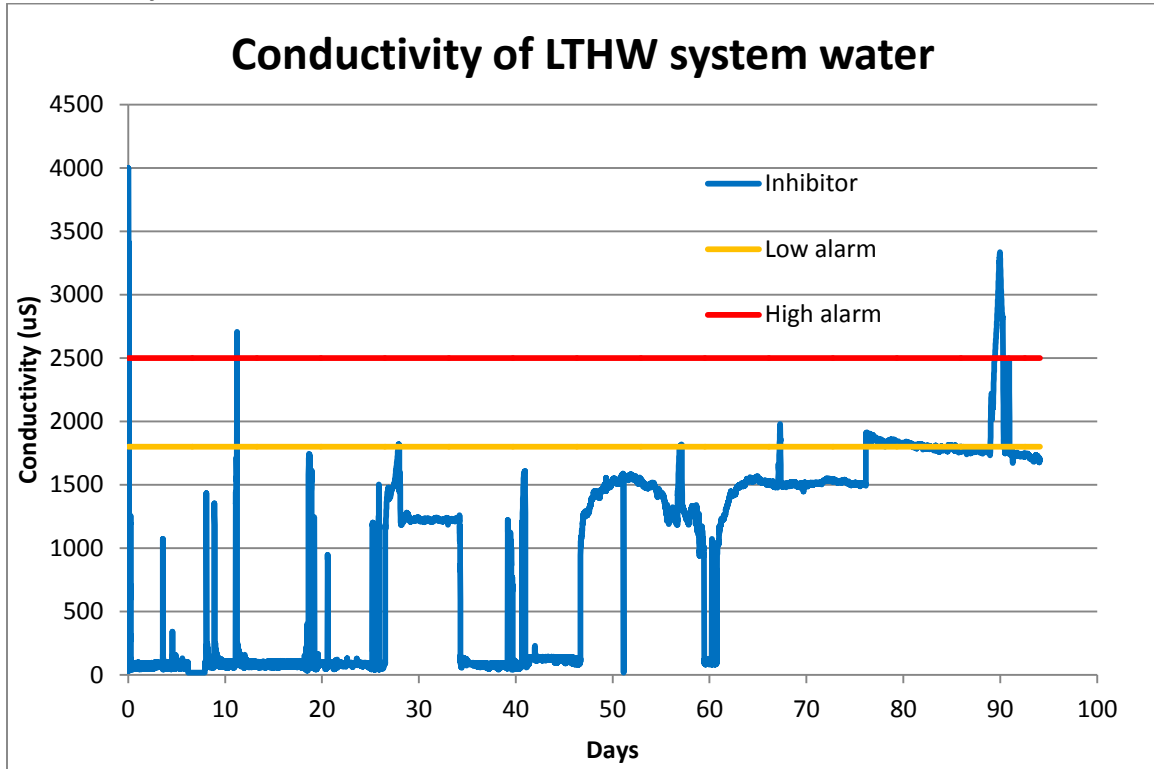
Conductivity

Issues of concern: The purpose of measuring the conductivity is to check on the concentration of inhibitor in the system. Unfortunately, early in the monitoring period the readings fluctuated wildly due to trapped air bubbles in the system. Latest results however suggest that the inhibitor level is below the recommended amount and this is consistent with the chemical analysis of the system water (see later in the report).

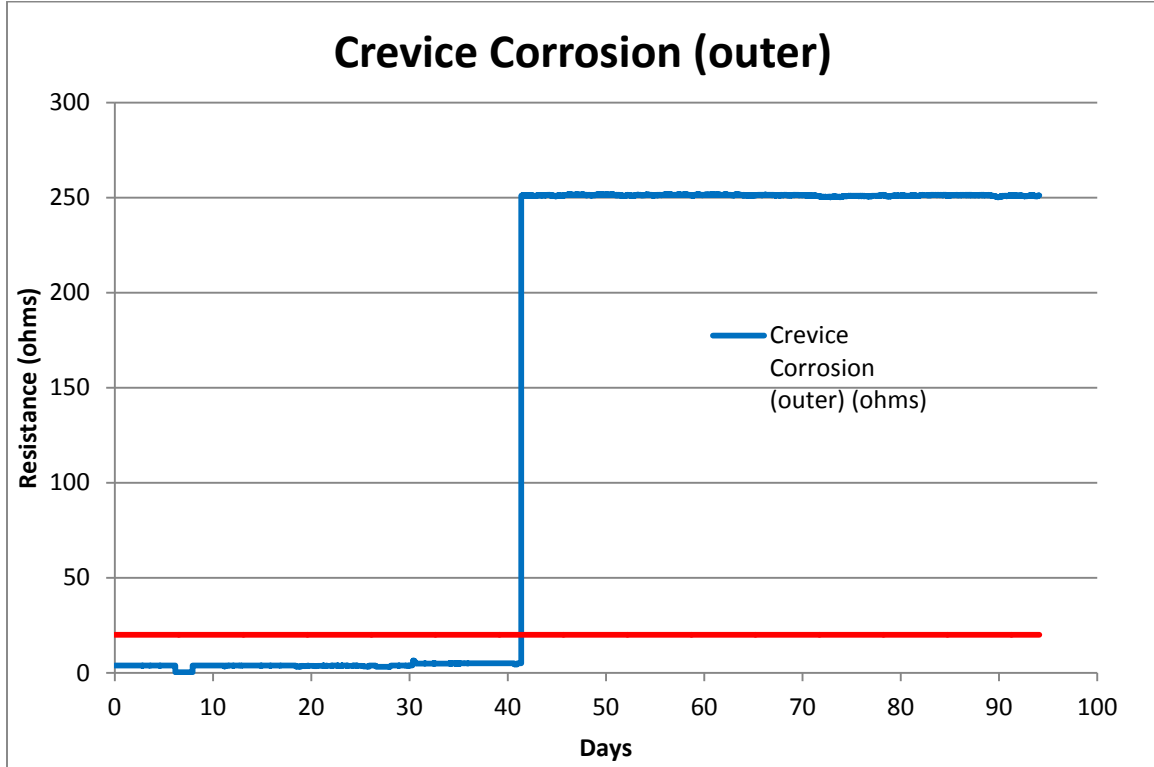
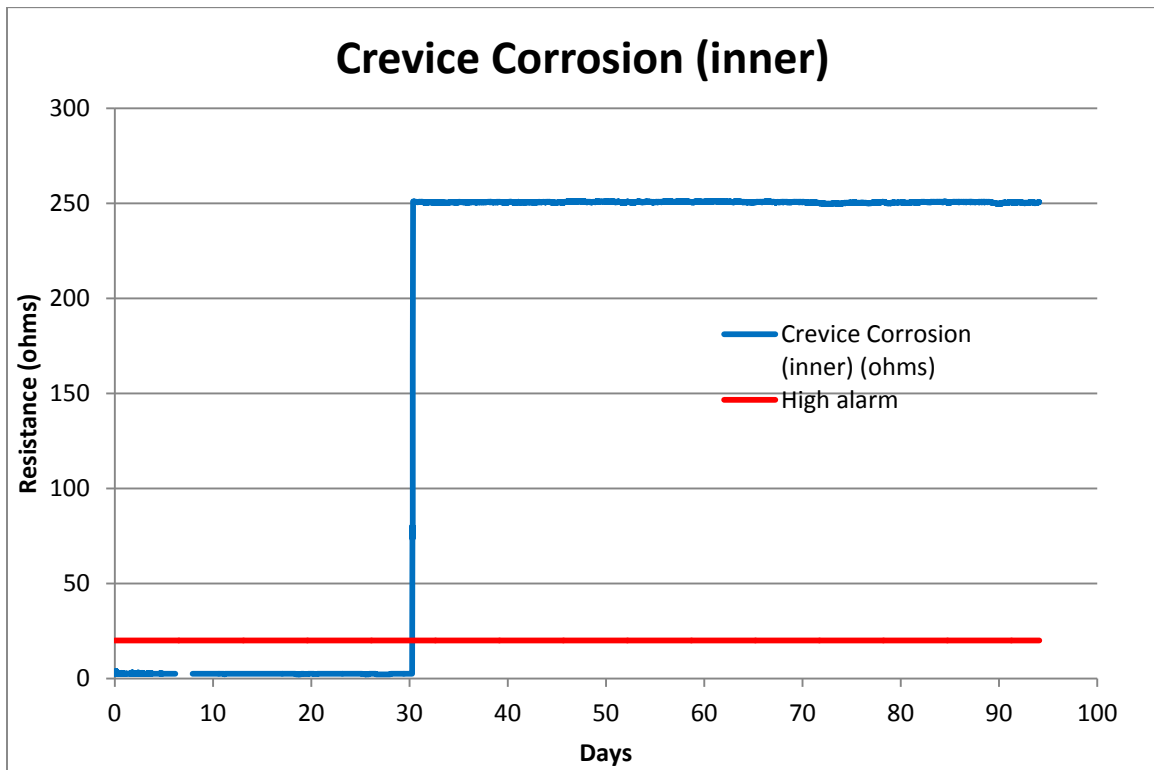
Crevice Corrosion

Issues of concern: Both of the thin (0.25mm diameter) steel wires in the crevice corrosion sensor have gone open circuit during the first 2 months of monitoring indicating that crevice corrosion of steel components has occurred.

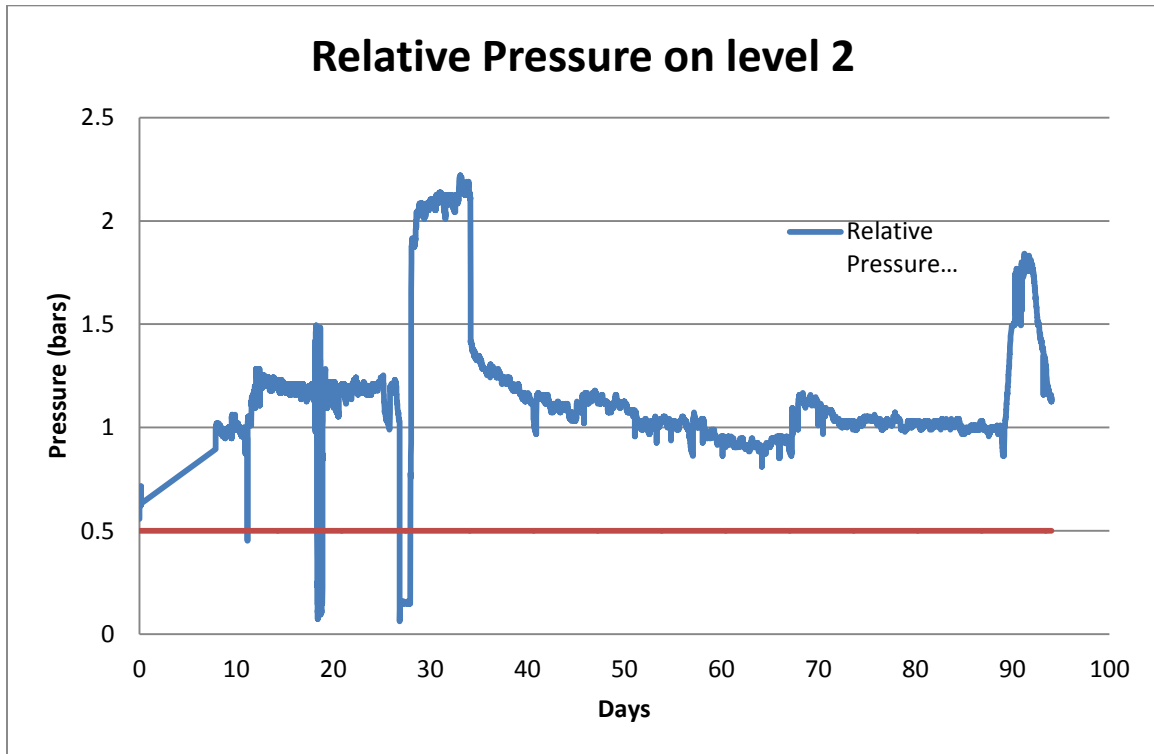
Pressure

Issues of concern: There have been two occasions where the pressure has dropped to unacceptably low levels, but it is understood that this coincided with maintenance activities. During the past 60 days the relative pressure in the system has remained around or above 1 bar and therefore will not have caused the problem of oxygenation. It is also encouraging to note that when the boiler in the system was switched off causing a rapid temperature drop, the pressure remained largely unaffected confirming that the pressurisation unit is working correctly.

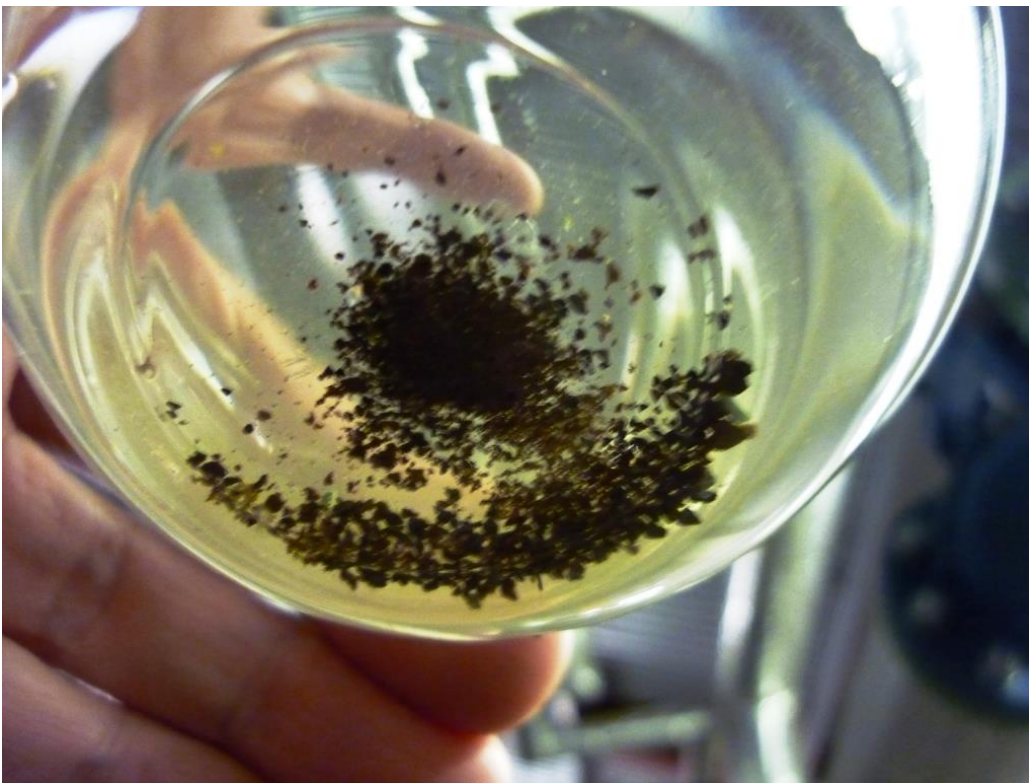
Also during the latest visit on 19th November it was noticed that a fair amount of corrosion debris came out of the drain point adjacent to the manifold of the upper floor (see figure 1). The composition of the debris is given in Appendix D

Figure 1: Debris from system drain point on upper floor

The presence of corrosion debris is also a cause for concern, particularly since it was collected from the drain point near the top of the system (bypass between flow and return). It is more than likely that a lot more debris will be found in the lower parts of the system. The analysis of this debris confirms (Appendix D) that corrosion of steel is occurring, with a high percentage of iron oxides detected. Some zinc and copper was also detected in the debris confirming that corrosion of brass components has also been occurring.

The analysis of the highly magnetic red/brown coloured platelet material has revealed that it is mainly Iron based, with evidence of some Calcium Carbonate Lime-scale (evidence of effervescing during dissolving), together with Phosphorus, Copper and Zinc.
