## Case Study: Tees Valley Hospital, Acklam, Middlesbrough

## Commissioning phase

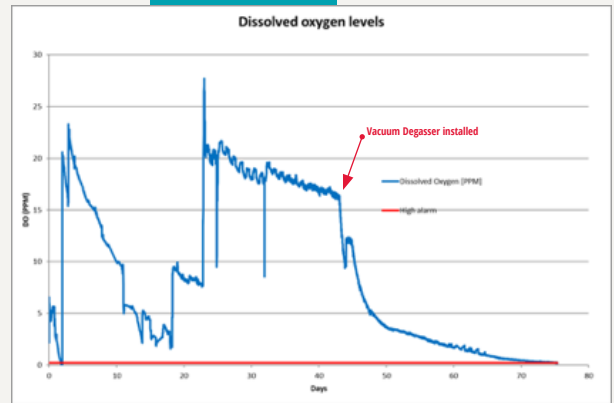
Early on during the pre-commissioning cleaning of the chilled water system, following flushing and filling activities, it became clear that DO was taking too long to return to acceptable levels (**figure 1**). With excessive oxygen in the pipework, corrosion risk was exacerbated, a particular concern in thin-walled carbon steel systems.

**Figure 1. Dissolved Oxygen in the Chilled water system during PCC and commissioning**

Following the identification of this issue, Hevasure advised the installation of a vacuum degasser; a solution which had an immediate and dramatic effect.

Within days, the dissolved oxygen was consumed and levels stabilised below 0.2 mg/L, minimising the risk of damage to the pipework and preventing expensive remedial action at a later date. If sampling had been the sole method of checking system condition during pre-commissioning cleaning, the oxygen issue would not have been picked up in time, meaning the water system would have started life in a compromised position, potentially leading to problems further down the line.

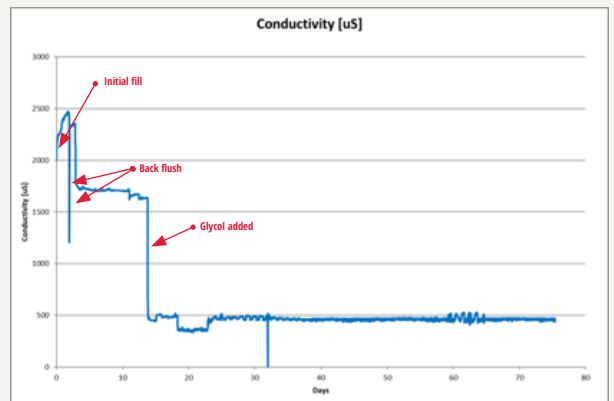
As well as identifying adverse conditions which can lead to corrosion, the monitoring system was also used to record when key events in the pre-commissioning cleaning process took place (**see figures 2 & 3**).

**Figure 2. Variation in conductivity during PCC and commissioning**

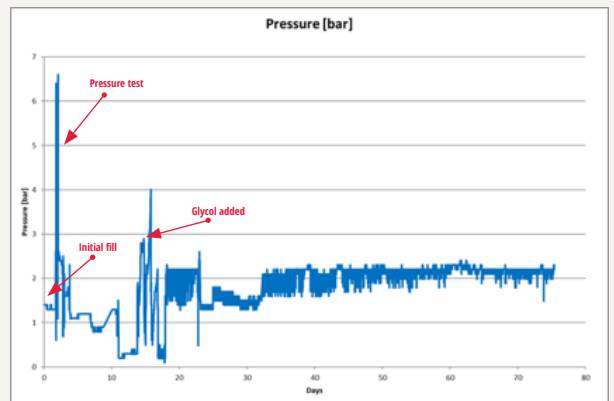
**Figure 3. Variation in pressure during PCC and commissioning**

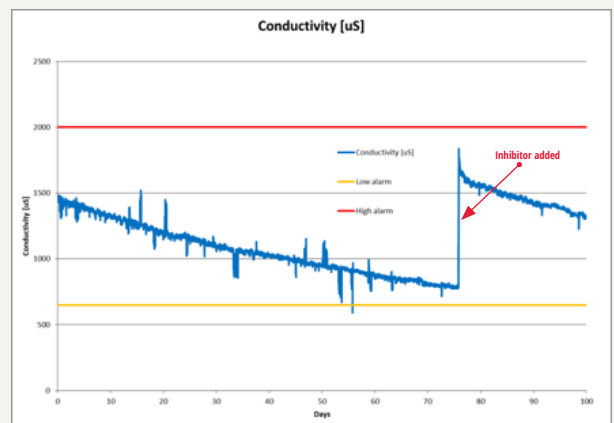
By measuring conductivity (and compensating for temperature) it is possible to determine inhibitor dosing levels. **Figure 4** shows that conductivity was decreasing over the first 70 days. The Hevasure monitoring unit issued an alert before conductivity fell below the bottom threshold and in response to this, Primary Water added more inhibitor which increased the conductivity to within guide levels.

**Figure 4. Variation in conductivity following hand-over**

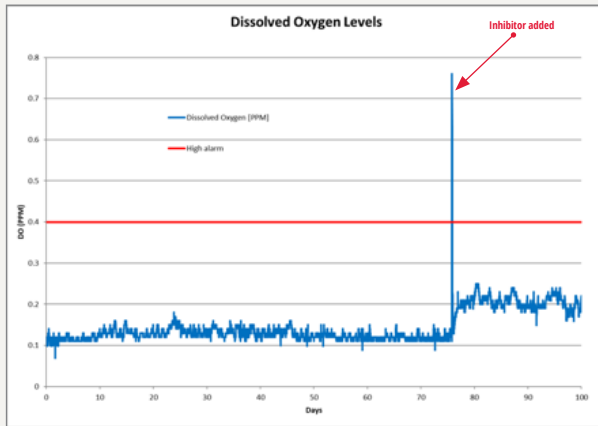
Although conductivity has continued to decrease over time, there is no evidence of corrosion (as measured by our galvanic current sensor) despite the fact that DO levels are slightly elevated. This indicates that the inhibitor is performing as intended and/or DO levels are insufficient to cause corrosion.

Figure 5. Variation in dissolved oxygen levels following hand-over

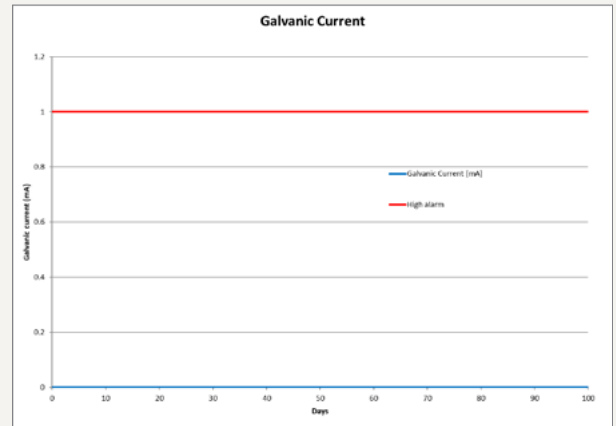
Figure 6. Galvanic currents at zero throughout the monitoring period proving that there is negligible steel corrosion
