Case Study: Fixing problems undetectable by sampling

Telephone House is a large office complex located in central London close to the Embankment. The building, which dates from around 1900, is listed due to its special architectural interest. Following numerous issues with the water system, including regularly leaking radiators, a Hevasure system was installed in May 2017 to provide a three-month Health Check.

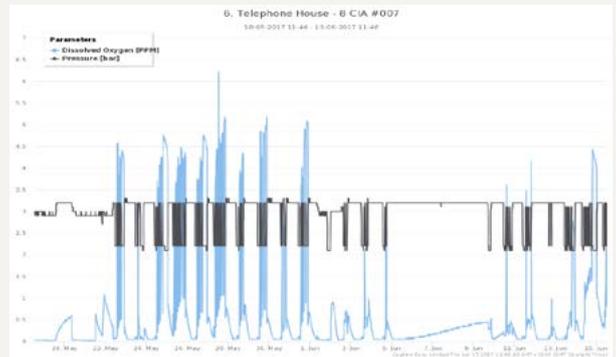
Graph 1 – shows the same cyclic DO and pressure pattern over the whole monitoring period – apart from the first week and the period from 5-11th June, the pattern is repeated and the peaks and troughs are consistent with heating /standby periods (i.e. pumps or boilers on/off cycles).

DO in a stable system wouldn't normally rise above 0.2ppm and pressure fluctuations would be significantly less than shown here. As conductivity remained stable throughout the period it was clear that there weren't any significant water losses or gains.

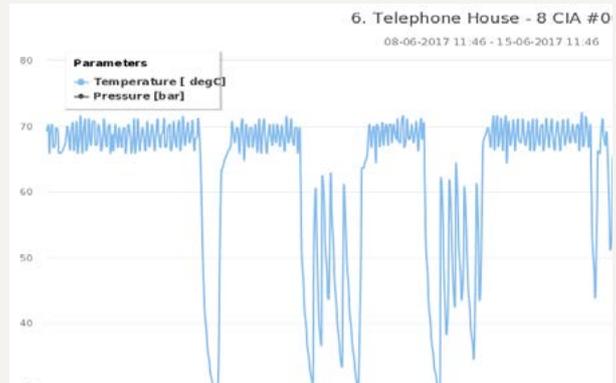
Graph 2 – shows the pattern of pressure in relation to the temperature of the LTHW system.

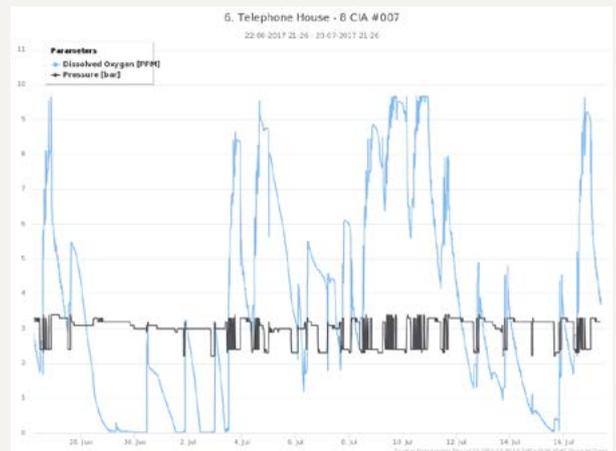
Graph 3 – shows the dissolved oxygen (blue) and the pressure (black) as measured at the base of the system. The oxygen levels peak every time the pressure drops.

Between 28 June and 4th July, indicated by an arrow, the

pressure doesn't drop far from the 3.3Bar level and during this period the oxygen levels remain mostly low and more stable. When the pressure is less stable and drops below 3 bar, oxygen levels rising again, peaking at 8ppm.

From this data we can see that at a higher resting pressure – or stabilisation of the resting pressure – restricts the ingress of fresh oxygen.

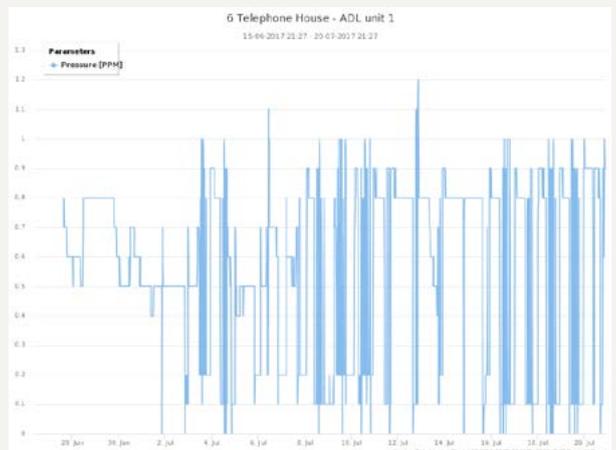
Graph 4 – shows the pressure recorded in the upper plant room sensor on the 4th floor. (measured in bar). The arrow shows the same “stable” period as the graph above.

Several times the pressure drops to 0 bar indicating negative pressure and air ingress on the 4th floor.

As suggested at the end of phase one, the pressure on the 4th floor is dropping low enough to cause air ingress and this is the source of the dissolved oxygen. The stable higher resting pressures from 28th June-4th July show a far lower oxygen ingress.

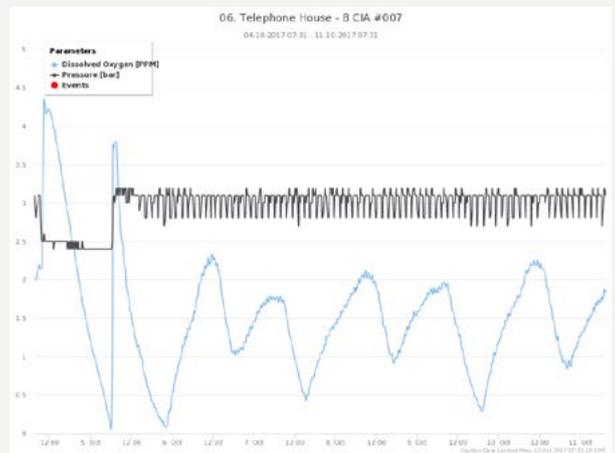
Graph 5 – The readings taken at the end of the period, show that there is some stability in the system over the seven days (3rd – 10th October) although the DO is still higher than desired. During this period there are no dramatic drops in base pressure, stopping the peaks in DO.

During this period work had been carried out to address some of the mechanical issues on the system. The expansion vessels were serviced and a fault was found with one of them. This was rectified in early August. The Air/dirt separator was also replaced on around the 28th September.

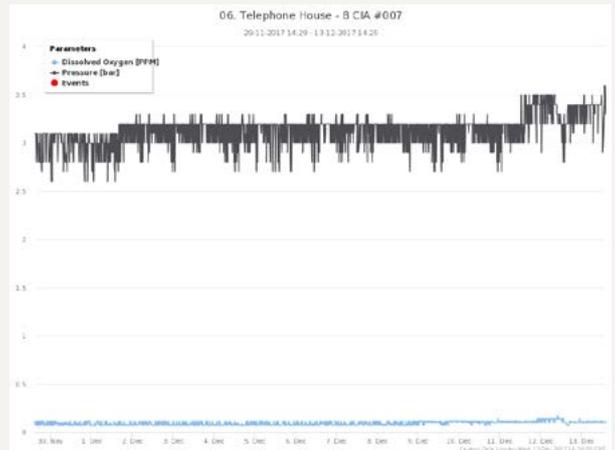
Graph 6 – The oxygen has fully stabilised, the system is healthy.
