## Case Study: Monitoring vs sampling - the benefits of instant results

### Project overview

Building no. 6 is a large, prestigious office in central London which had a heavily contaminated Chilled Water (CHW) system, with high levels of dissolved iron (108mg/l) and suspended solids (138mg/l), which, if left unchecked would lead to inefficiencies in the system, shortened lifespan and potential breakdown.

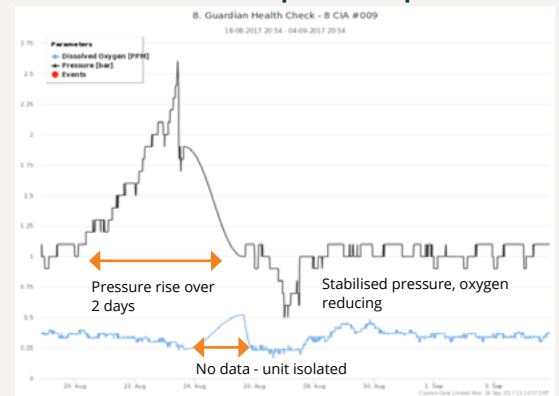
### Data before and after pressure spike

Within the first two weeks of installation the Hevasure system tracked pressure spikes and the actions and system conditions that had caused them. At the time, the site engineers noticed noise and possible air in the system – an indication that a previously non-circulating area had been re-opened and was introducing air.

Once the pressure spike issue had been resolved, DO returned to 0.3ppm and the galvanic and crevice corrosion sensors indicated negligible corrosion rates.

Despite the fact that the Hevasure unit showed the system to be in reasonably healthy condition, free from corrosion and water losses, it did detect a consistent level of DO at around 0.3ppm. Recommended levels for a healthy "aeration free" system is less than 0.2ppm. The pressure, which was being

measured close to the top of the system, was also lower than it should be, occasionally dropping further.

After some investigation into the layout of the system, including an additional section of pipework which was added to the roof area, very low pressures were noticed. Sections of the systems were also noisy with what sounded like air in one or two areas.

The site engineer team checked this and when the original drawings were compared they discovered around 20 Air Auto Valves (AAVs) missing from the top of the system.

Eight new AAVs were subsequently installed and the aeration noises have now disappeared.

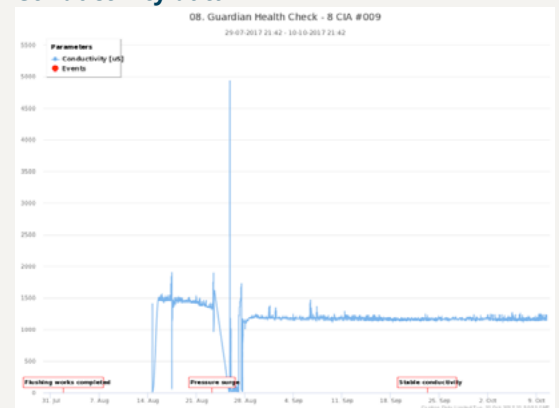
### Conductivity data

### Conductivity showing as stable after the pressure surge incident.

Following the pressure surge, around 400 litres of water had to be introduced to the system, causing a sudden drop in conductivity (28th August). The engineers responded by re-dosing the system with inhibitor until the conductivity reached an acceptable level.

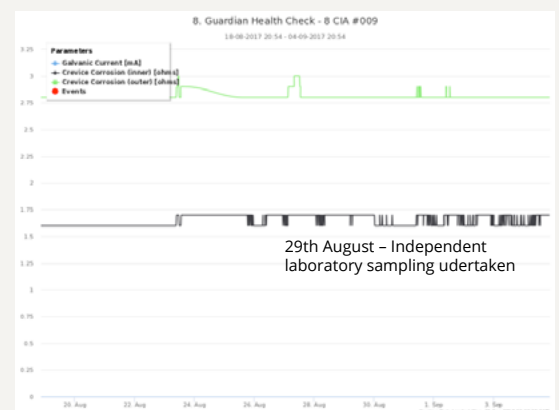
### Corrosion data

Providing readings every 15 minutes, all the indications from the Hevasure unit demonstrated that the conditions in the system were not corrosive, with the three different sensors showing low outputs following the flushing works.
