## Case Study: Tees Valley Hospital, Acklam, Middlesbrough

## Commissioning phase

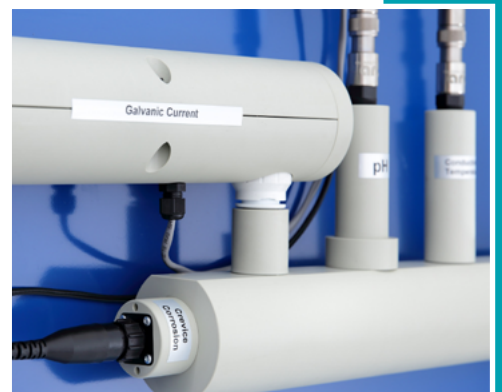
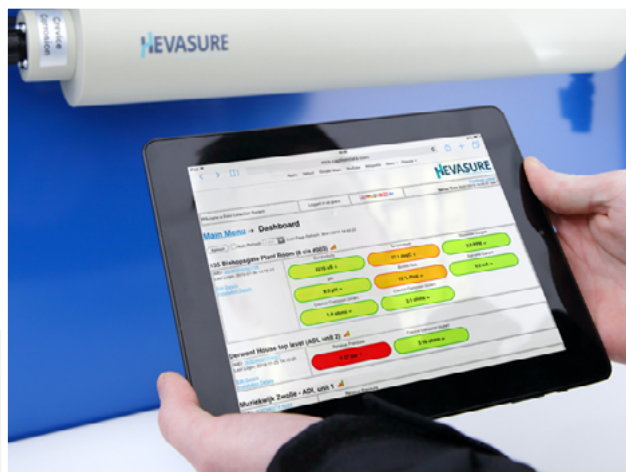
As well as identifying adverse conditions which can lead to corrosion, the monitoring system was also used to record when key events in the pre-commissioning cleaning process took place (**see figures 2 & 3**).
